Subject: EPA Comments on MidAmerican Energy Co, George Neal North Power Station,
Sergeant Bluff, IA
Round 7 Draft Assessment Report

From: Jana Englander, OSWER, US EPA

Date: January 27, 2011

Walter Scott Energy Center Draft Report Comments

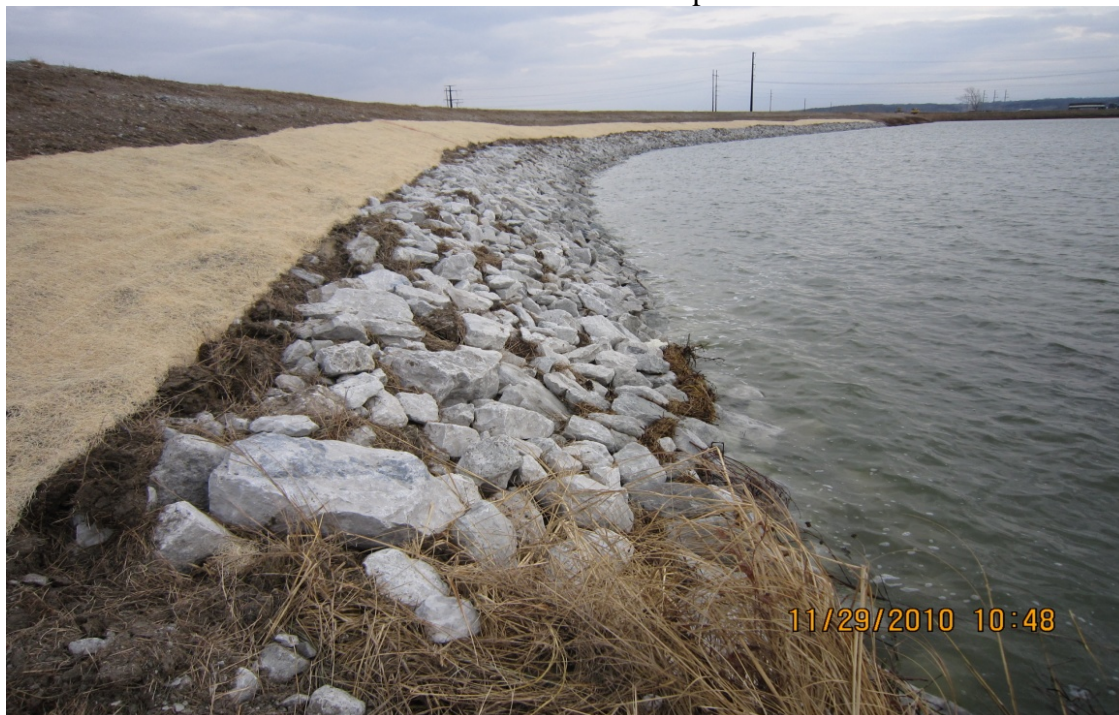
Photo 6 – Placed rip-rap to protect wave erosion action
Southwest side of South Surface Impoundment

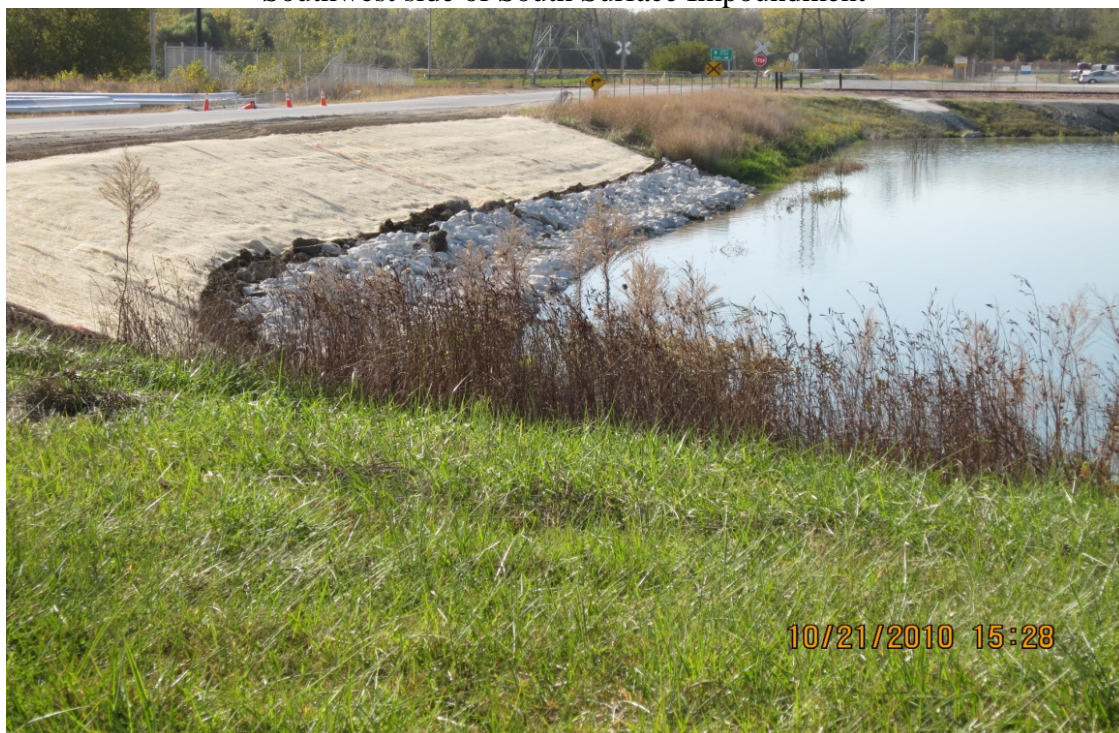
Photo 7 – Placed rip-rap to protect wave erosion action
Southeast side of South Surface Impoundment

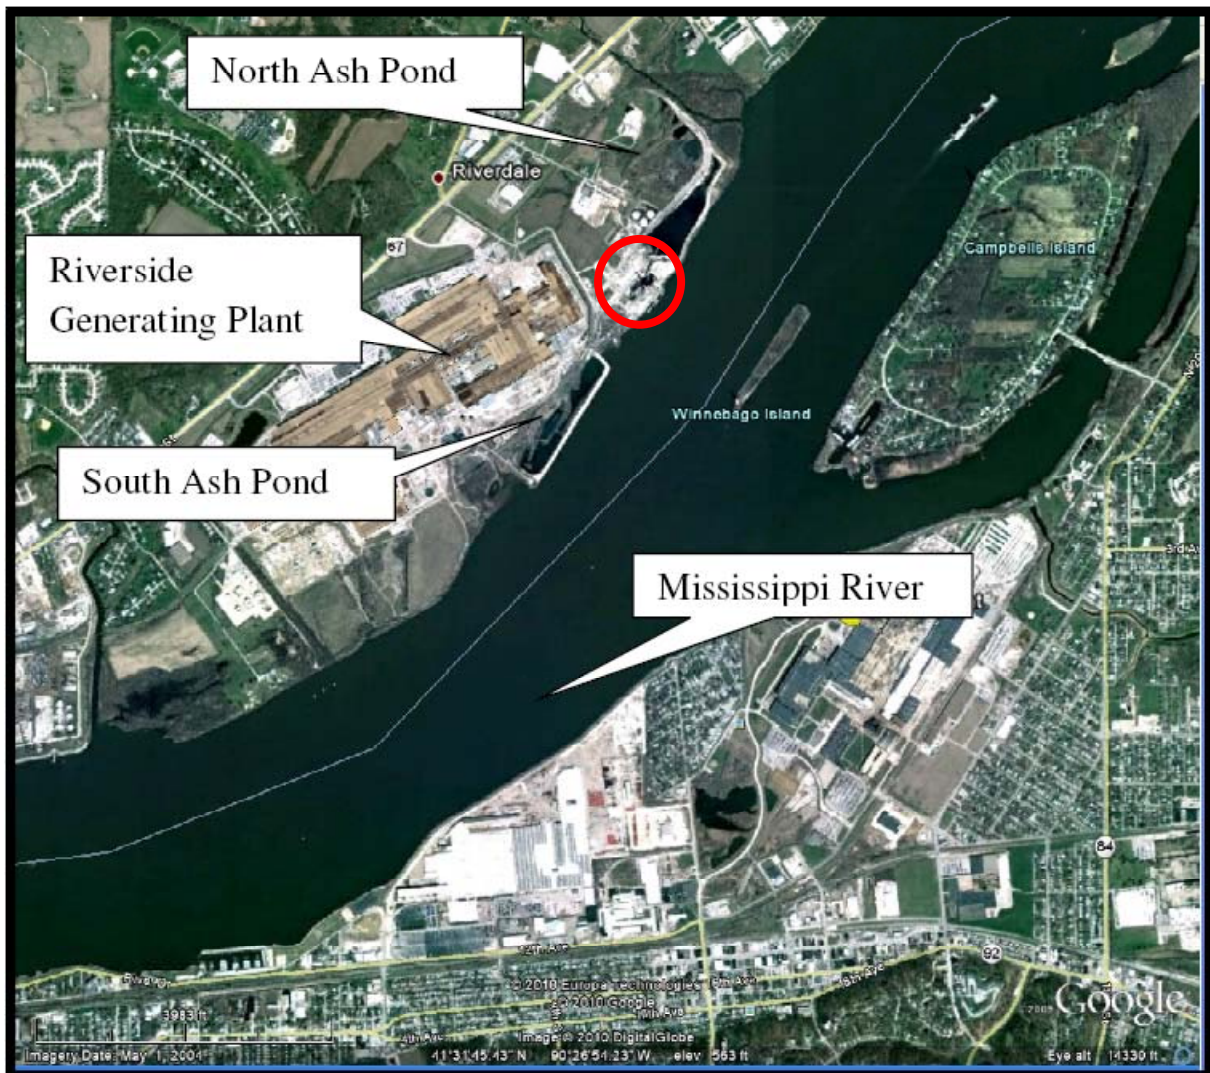
Figure 2.1-2: The photo incorrectly labels Alcoa as the Riverside Generating Plant. Riverside is actually just north of the South Surface Impoundment (South Ash Pond) as shown in the red circle below.

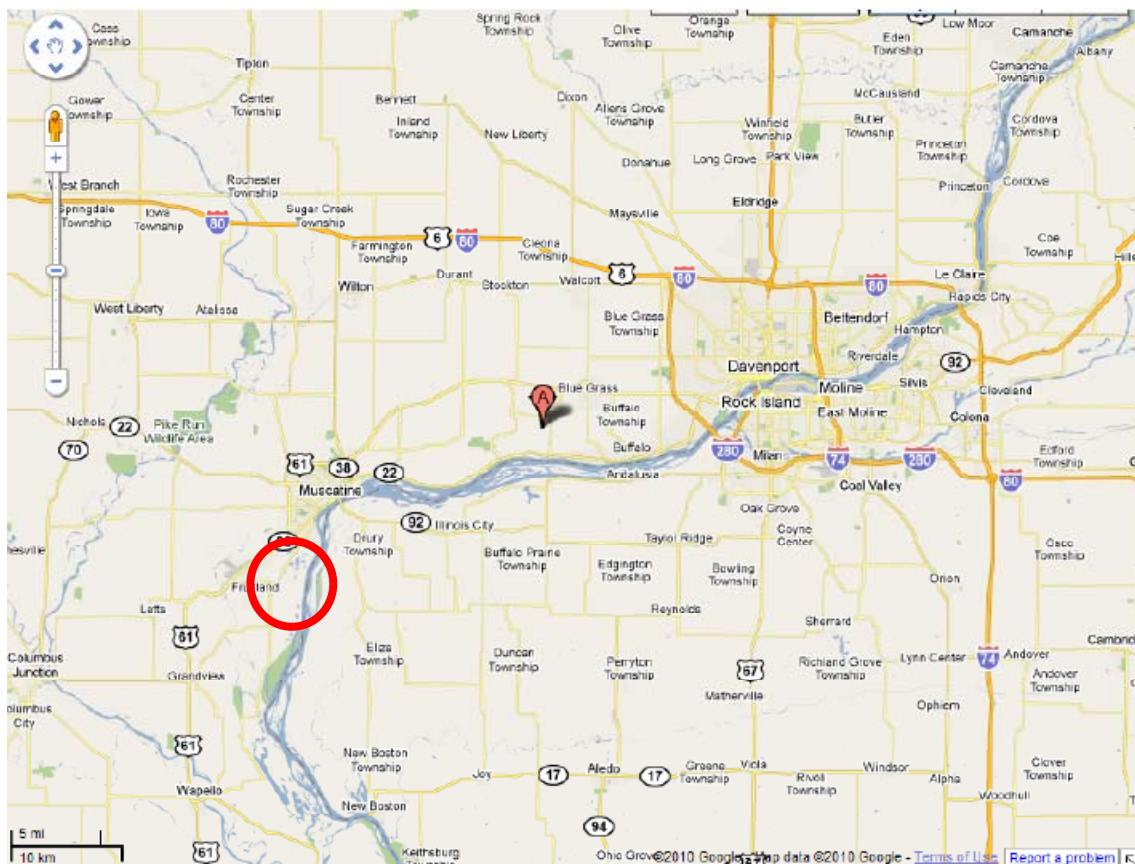
Section 2.1: The general description and figures 2.1a and 2.1b relate to IPSCO Steel, not Louisa. The Louisa Generating Station is further southwest near Fruitland, Iowa, as shown in the red circle on the map below.

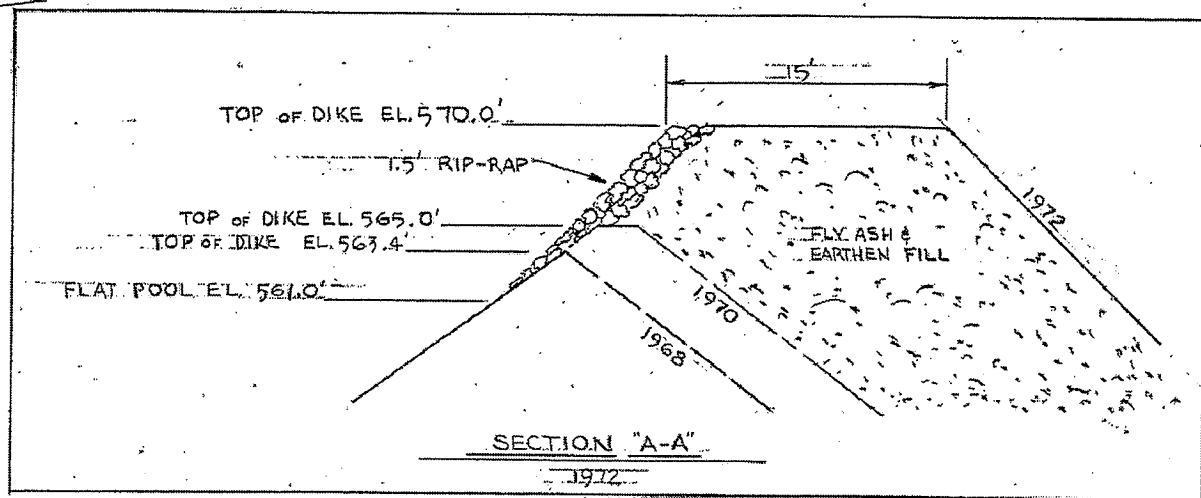
Figure 1. Section A-A, 1972 from Riverside South Fence and Ash Fill Area, Iowa-Illinois Gas and Electric Company drawing No. 22-500-108-012.

Due to the location of the borings on the crest of the existing levee, the borings do not appear to have encountered the original 1968 levee section or the 1970 levee widening, which now form the toe of the existing levee section due to the subsequent enlargement of the levee toward the landside (see Figure 1). A review of records by MEC show that pre-construction proposal documents indicate the contract required the use of rip-rap for construction of the 1968 levee section. The construction specifications that were supplied to vendors at bid specified “mine run quarry rock”. An August 5, 1963 RGS cost estimate for the 1968 levee indicates the levee was to be constructed in the Mississippi River out of riprap and extend from the Riverside Station to the ALCOA screen house. The estimated quantity of riprap required was 13,159 cubic yards. A June 1967 summary of bids for the project indicates the levee was planned to be constructed by dumping the riprap from barges in the river. Based on the estimated quantities of riprap and proposed alignment, we estimate that the riprap quantity would be sufficient to construct a 7 to 8 foot tall levee dike with 2:1 side slopes. These dimensions are consistent with the plan dike top elevation shown for the 1968 levee and the surveyed Mississippi River bottom (alluvium) elevations.

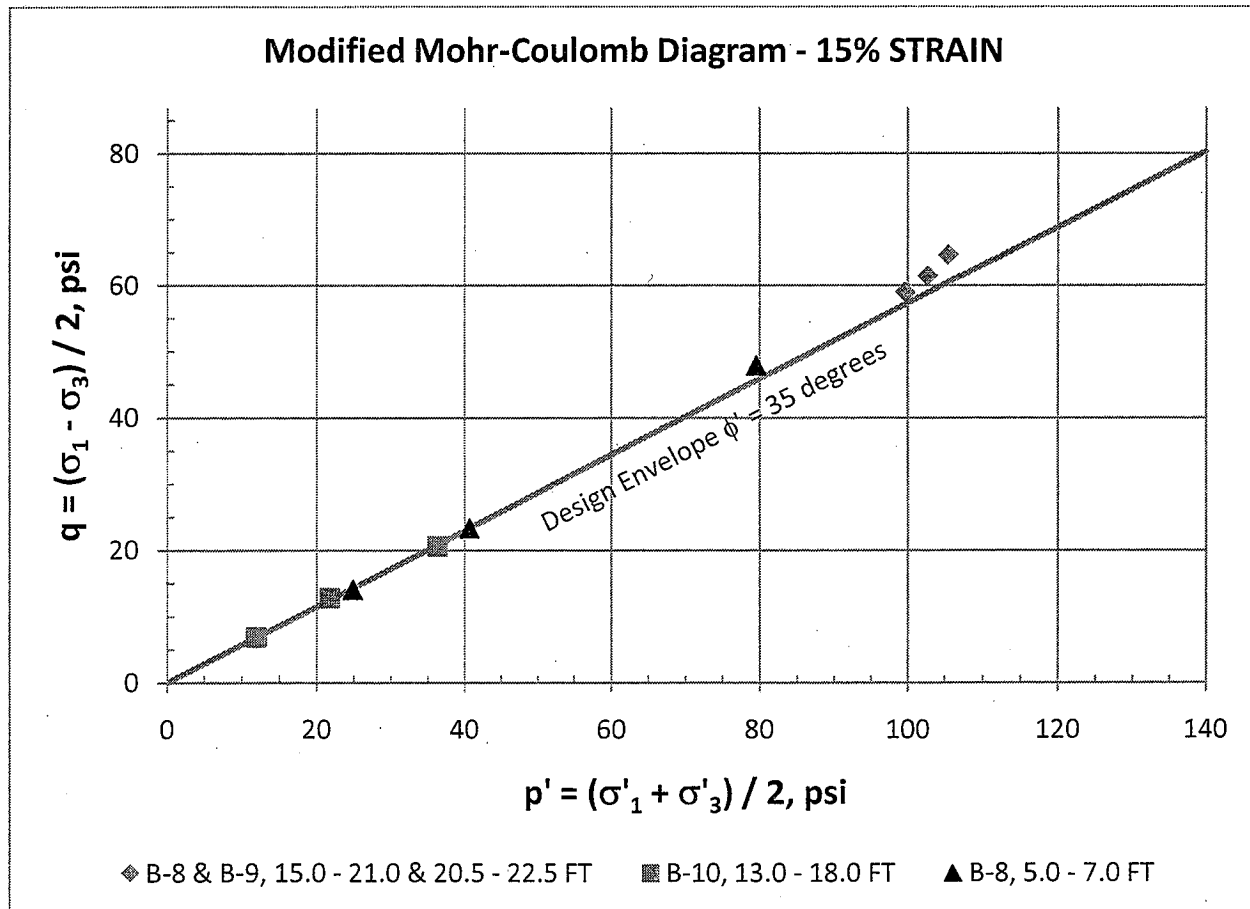
Figure 4. Design Shear Strength Envelope for Remolded Ash Samples.

Results of the CIUC triaxial shear tests performed on remolded samples of the levee embankment materials are shown in Figure 4 on page 9 in Modified Mohr-Coulomb form. Due to strain softening behavior in one set of tests (B-8 & 9/Composite), all test results were evaluated for high strain (15% axial strain) conditions, representing the lowest developed friction angles for the materials. Although one test series exhibited a small cohesion intercept (B-10, 13-18 ft. depth), the composite, design strength envelope shown in Figure 4 was evaluated with effective cohesion set to zero. These data were used to establish probable design shear strength parameters for the embankment materials. The data for individual tests shown in Figure 4 are summarized in Table 3.

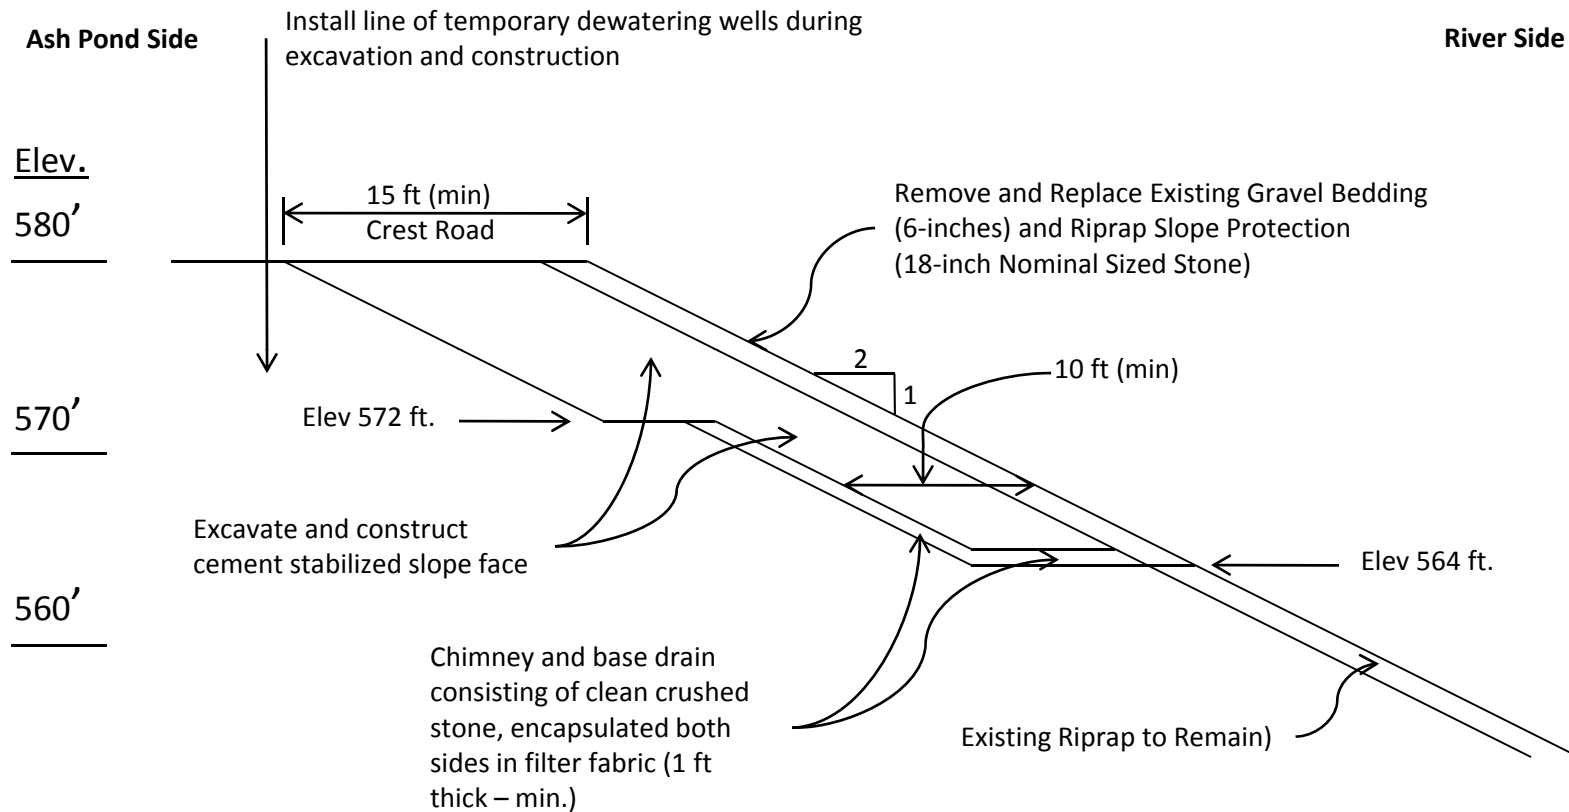
EXHIBIT D-1A

Ash Pond Embankment Slope - Typical Section
Cement Stabilized Slope Face Remediation Option

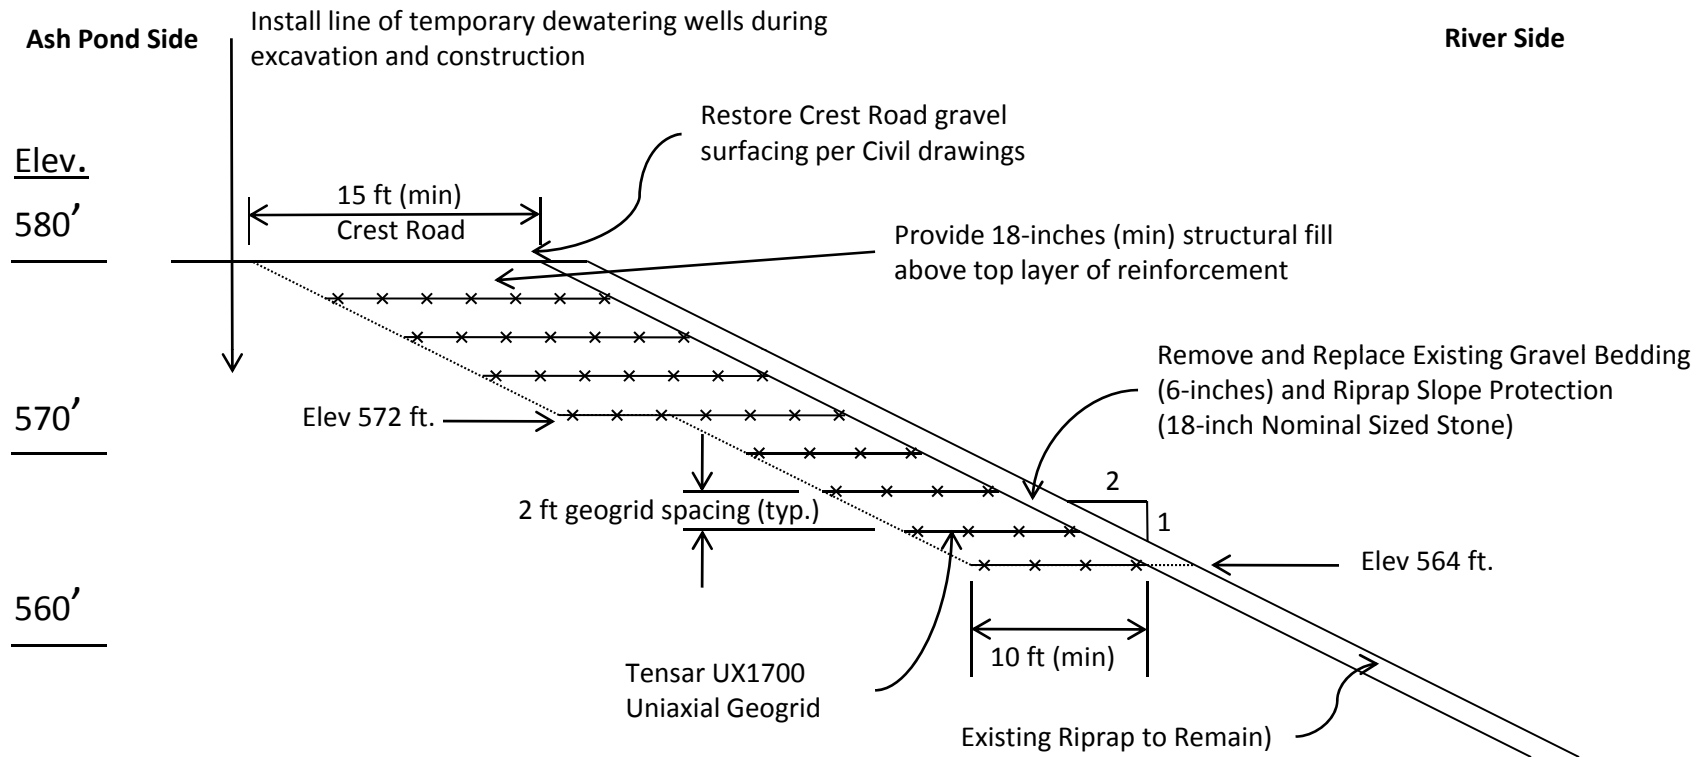
EXHIBIT D-1B

Ash Pond Embankment Slope - Typical Section
Geogrid Reinforced – Mechanically Stabilized Slope Face
Remediation Option
